## PIPELINE ACCIDENT REPORT

PHILADELPHIA GAS WORKS  
NATURAL GAS PIPELINE RUPTURE,  
EXPLOSION, AND FIRE  
PHILADELPHIA, PENNSYLVANIA  
MAY 11, 1979

NTSB-PAR-79-3

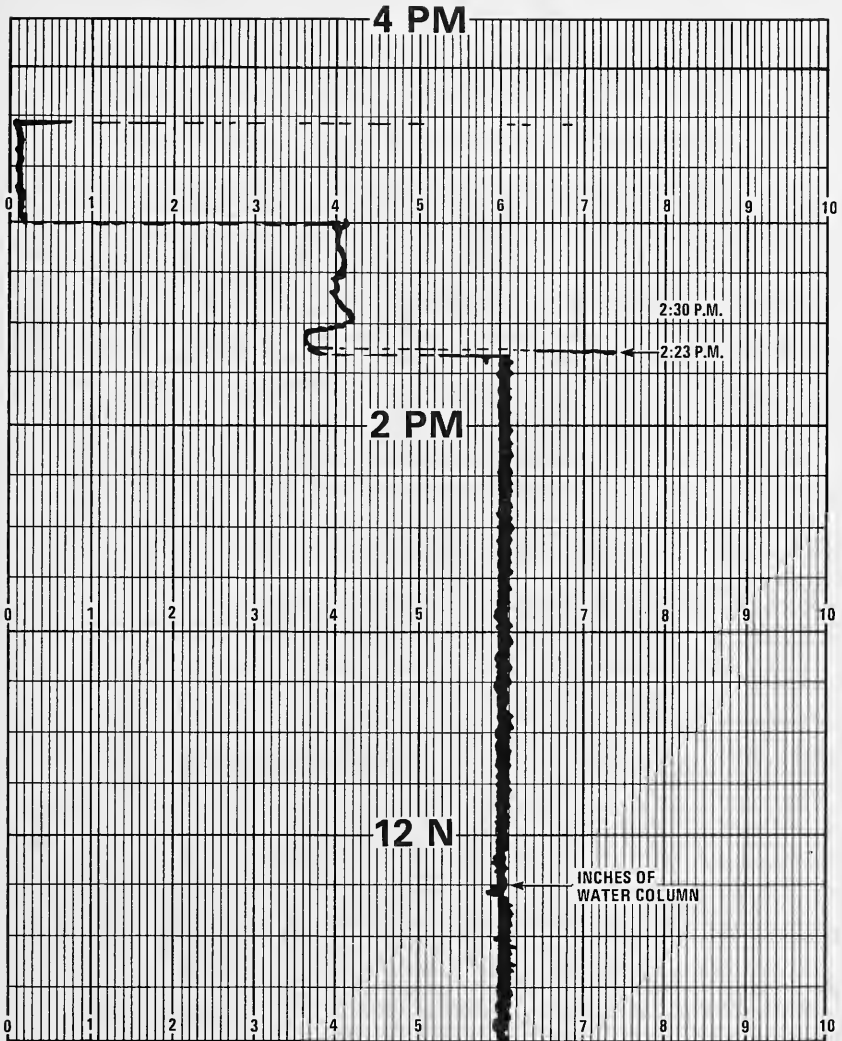
Figure 2. Pressure-recording strip chart.

At 2:30 p.m., a gas pressure recorder which was connected to the gas system that ran under Margaret Street, and located 1 1/2 blocks from the intersection, indicated that the pressure had dropped from 6 to 3.6 inches of water column. (See figure 2.) This information was telemetered into the PGW distribution department dispatcher office where an alarm sounded. A pressure specialist was dispatched to the location 1 1/2 blocks from the accident site. He checked the pressure chart which indicated a failure somewhere on the gas main. The chart showed the pressure drop in inches of water column and the time of the drop in pressure. The pressure-recording chart was found to be 7 minutes slow, which meant that the indicated 2:23 p.m. pressure drop actually occurred at 2:30 p.m. While the specialist was checking out the equipment, the explosion occurred.

been noticed, and the pressure-recording chart 1 1/2 blocks away had been constant in the recent past. Therefore, the Safety Board concludes that the gas main collapsed at 2:30 p.m. on May 11, 1979, as indicated by the rapid drop from 6 to 3.6 inches water column shown on the pressure-recording chart.

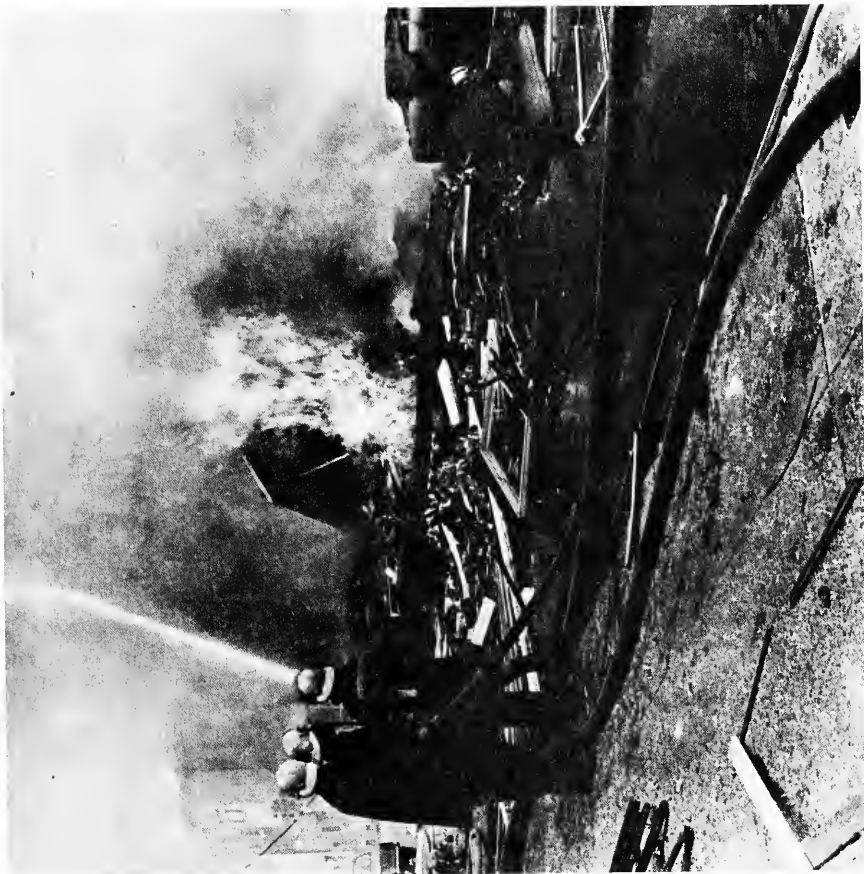
Figure 3. Firefighters controlling the fire in debris of buildings at 4701 and 4703 Tacony Street.

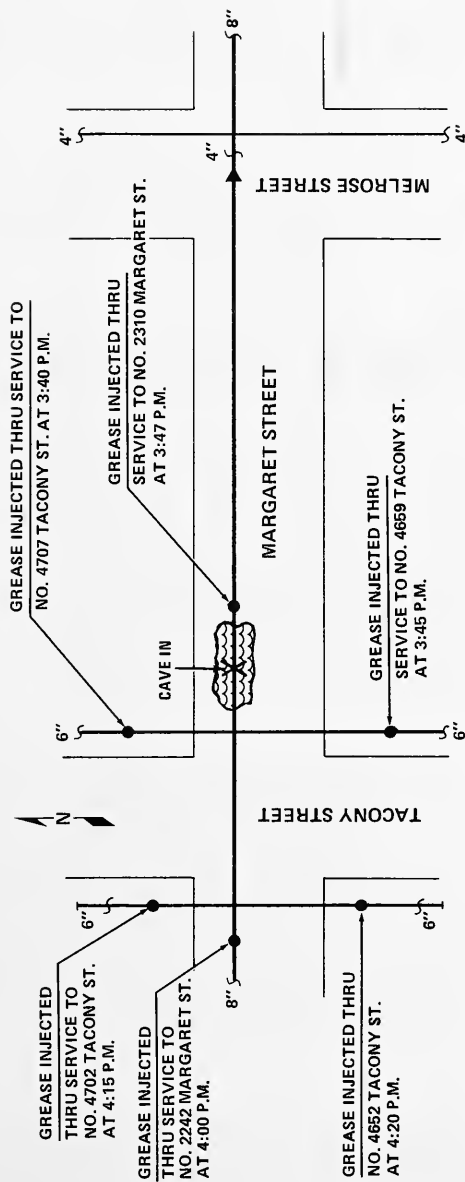
Figure 4. Grease injection locations.

At 7:30 p.m., while the search for survivors continued, PGW customer service crews continued the gas odor survey of all houses near the accident site. At 9:45 p.m., the PGW distribution crew completed cutting and capping all natural gas mains leading to the intersection. Six "greased off" locations were capped. (See figure 4.)

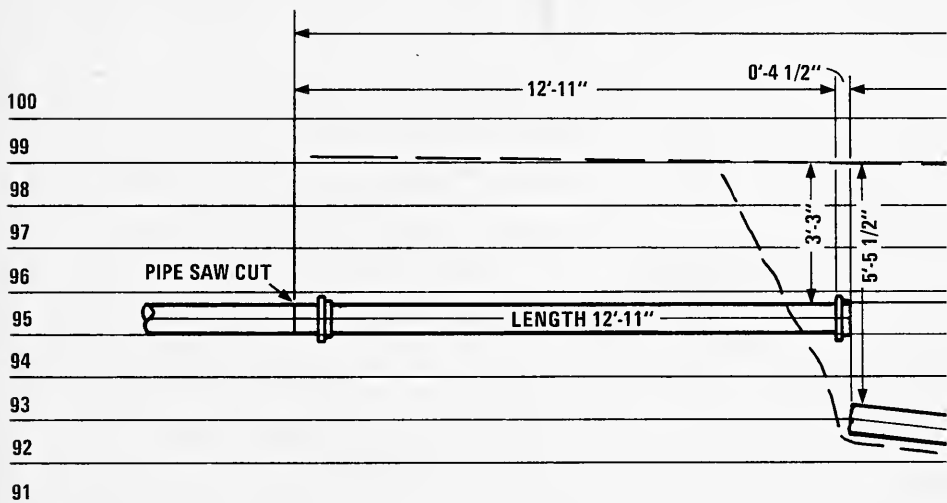
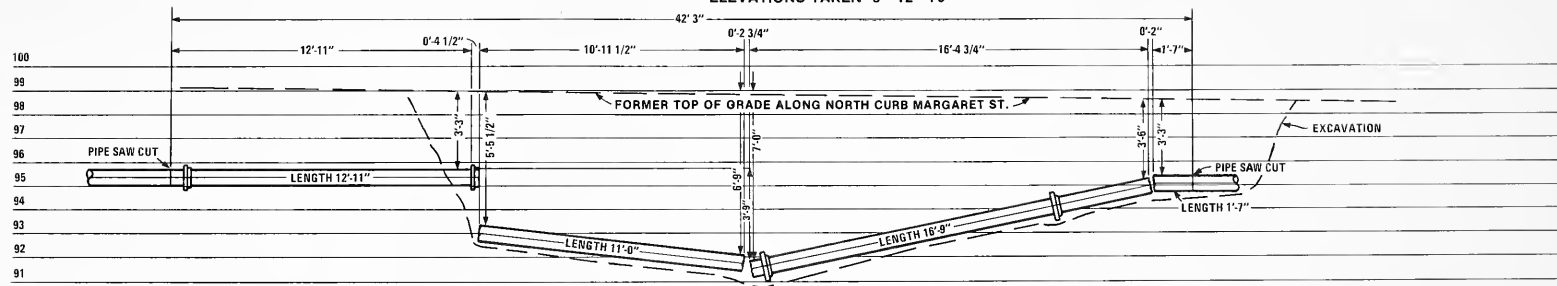
**FIGURE 5.**  
**PROFILE VIEW LOOKING NORTH 8" CAST IRON GAS MAIN**  
**ELEVATIONS TAKEN 5-12-79**

When the hole was cleared of debris and the water was pumped out, investigators found that the 8-inch, cast-iron gas main below the street was broken in three places. (See figure 5—Profile.)

When the gas main was uncovered, the pipe to the east was lying at a slight angle from the horizontal. Excavation to the west exposed two breaks in the line, one end of this broken section was 3 feet 9 inches below its former horizontal position. (See figure 5—Profile.) Further excavation to the west revealed a third break about 11 feet west of the second break. The gas main had shifted laterally a total of 1.325 feet from its original position. (See figure 5—Plan View.) The broken main ends and segments of the water main were cut off and visually examined by a Safety Board metallurgist. The pipe was also sent to the National Bureau of Standards for further metallurgical examination.

The 8-inch, cast-iron gas main, although installed 80 years ago, was found to be in good condition, without extensive corrosion, and within definition for gray cast iron of that era. The light corrosion on the fractured pipe face, the ease with which it was removed, and the lack of corrosive attack on the fractured faces of the pipe itself indicated a very recent break. Cast iron when exposed to the elements will often show traces of rust in a matter of hours. The pipe, in 12- and 16-foot sections, had hung unsupported for a long time in a span until it snapped and broke, due to a combination of factors such as the pipe's own weight, traffic vibrations, pavement settling, or other unknown outside forces. No reports of gas odor had been received recently from this area, no gas pressure reductions had

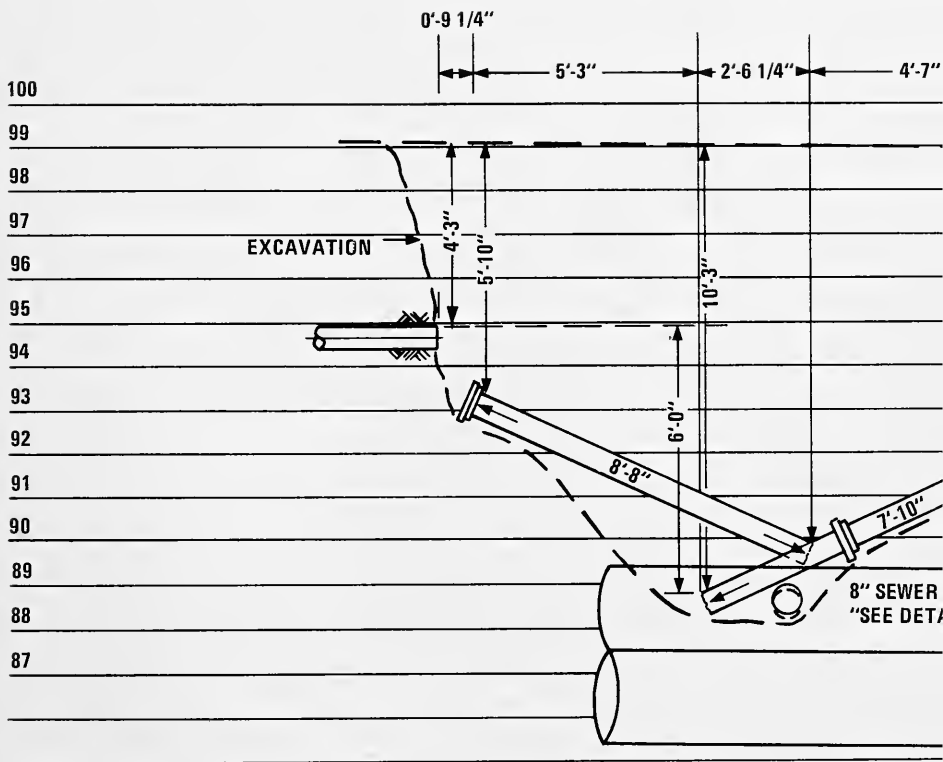
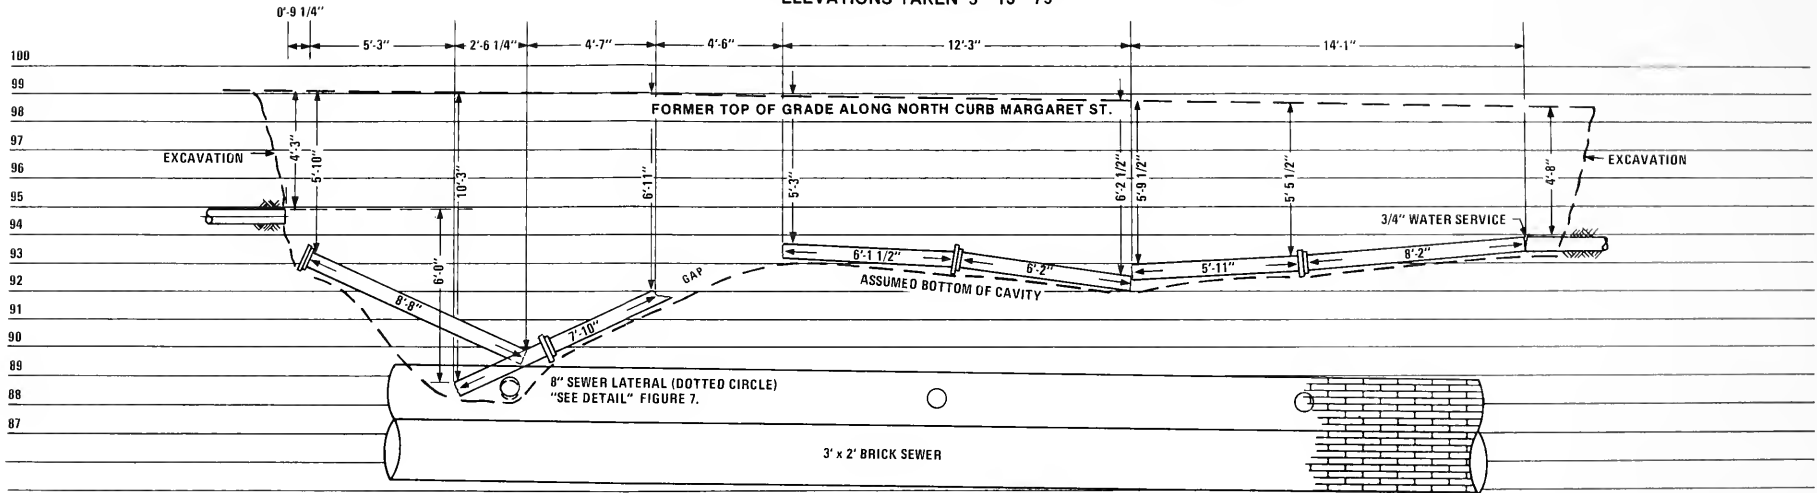
**FIGURE 6.**  
**PROFILE VIEW LOOKING NORTH 6" WATER & 3' x 2' SEWER**  
**ELEVATIONS TAKEN 5-13-79**

A 6-inch, cast-iron water main in the hole was broken in five places. (See figure 6.) The water main had been installed in 1941 with 4 feet 3 inches of cover. The deepest break in the water main occurred where the main crossed above an 8-inch sewer lateral from a rowhouse. At this point one end of the broken main had dropped 6 feet below its original horizontal position, and had severed the 8-inch sewer lateral connection with the sewer main. (See figures 6 and 7.) The oval-shaped, 3-foot by 2-foot brick sewer was very old, but was found to be intact in the

2. Because of the difficulty in removing the corrosion product from the fracture and because of the corrosive attack of the fracture features, it appeared that the pipe had been fractured for some time.

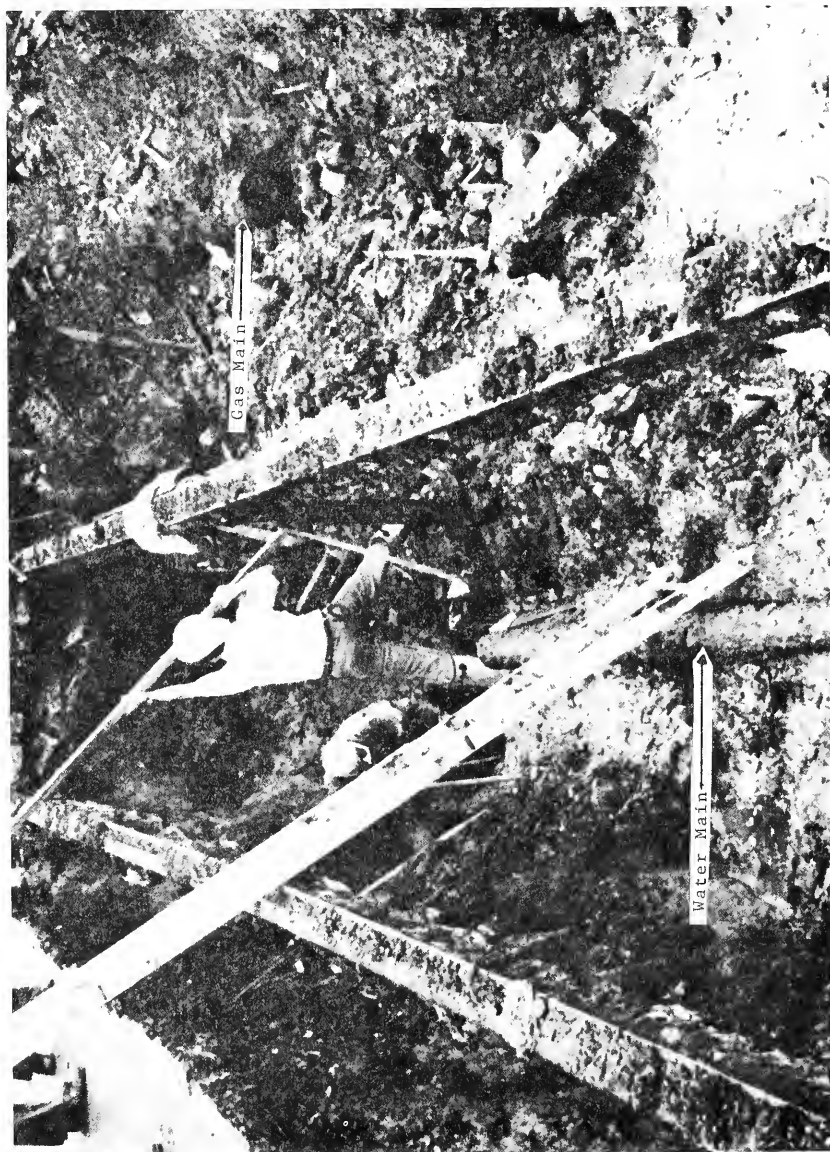
3. The cavity beneath the road appeared to have been in existence for a considerable time before the road collapsed. The trolley track apparently had supported the road surface and all the vehicular traffic on the road up to the time of the cave-in. (See figure 8.)

Figure 8. Partial view of cavern over which trolley track had supported pavement.

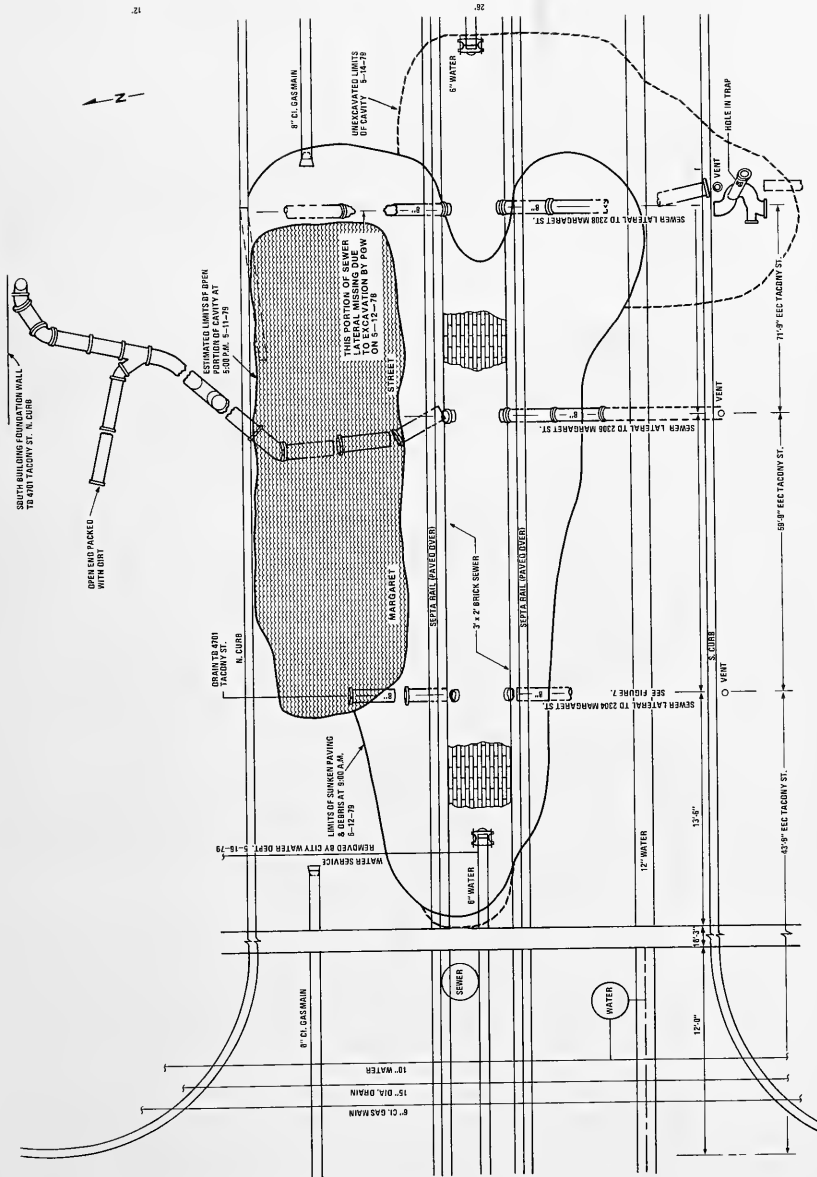
6. Six sanitary sewer laterals were excavated and examined. These laterals served the rowhouses and tavern adjacent to the cave-in. In general, the laterals were not in good condition; three of them appeared to have been disconnected from the sewer main for some time. (See figure 9). The ground around these laterals contained sewer sludge.

Figure 9. Plan view of initial cave-in with adjacent damaged sanitary sewer laterals.

The examination of the cave-in revealed that the large cavern had been in existence for a long time and had been created by a slow erosion process. The poor condition of the three sewer laterals and of the soil around them leads the Safety Board to conclude that seepage from these laterals contributed to the erosion that created the cavern. The openings in the sewer main caused by the broken laterals, allowed sewer backup during periods of heavy rain to escape and erode the immediate area. Water escaping from the fracture in the water main, which tests indicated had existed for some time, also probably contributed to the erosion. The break in the water line was not complete; it was probably more of a fissure which let water escape under pressure and helped to erode the cavity. Had the water pipe broken completely, water pressure to the area would have been disrupted, residents would have complained of no water or low water pressure, and the break would have been detected and repaired within a few hours.

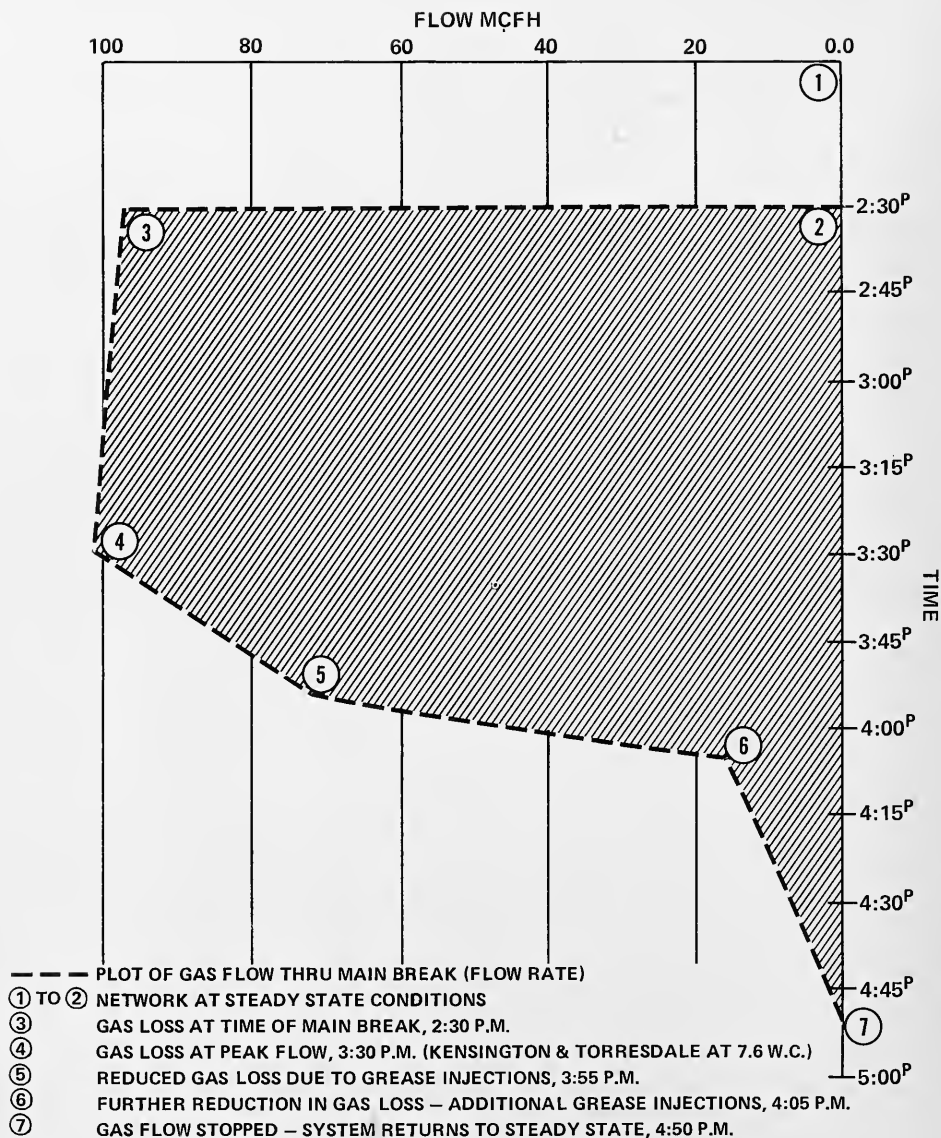
Figure 10. Time-flow plot of gas loss.

Calculations of gas loss. — Computerized calculation of gas flow showed a total of 152.76 MCF <sup>2/</sup> of gas lost from 2:30 p.m. to 4:50 p.m. (See appendix B.) From 2:30 p.m., the time of the failure, until 3:05 p.m., the time of the explosion, a total of 50 MCF of gas entered the cavity beneath the street. It took approximately 3 minutes to fill the estimated 4,780-cubic-foot cavern at a rate of 1,619 cubic feet per minute.

TOTAL GAS LOSS = 152.76 MCF = CROSS HATCHED AREA UNDER CURVE OF FLOW RATE
